# **Reserve Study Level II**

**Prepared for Nautica Soundview**

**2026 Fiscal Year**

Prepared by CEDCORE, LLC

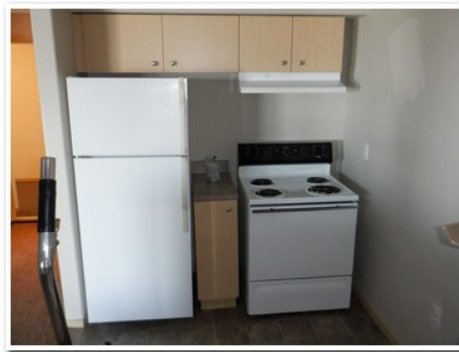
#### Recreation - Appliances: Replace

Location: Kitchen  
 Quantity: 1 Allowance  
 UL: 20  
 RUL: 0  
 Current Cost: \$3,600  
 Condition: Assorted Condition  
 Funding Basis: Funded based on the typical life expectancy

We have included an allowance for appliance replacement. Use of this allowance is at the discretion of the Board.

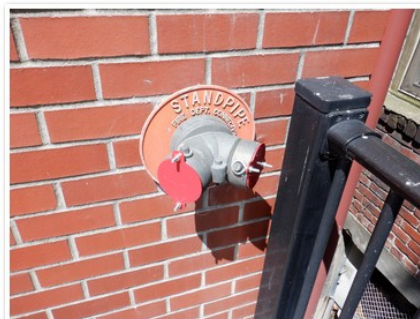
#### Building Exterior - Brass Fire Department Connections

Location: Near Front Entrance  
 Quantity: 6 Each  
 UL: 1  
 RUL: 0  
 Current Cost: \$2,400  
 Condition: Not Applicable  
 Funding Basis: Funded based on Association direction

Requested by the Association due to numerous thefts.

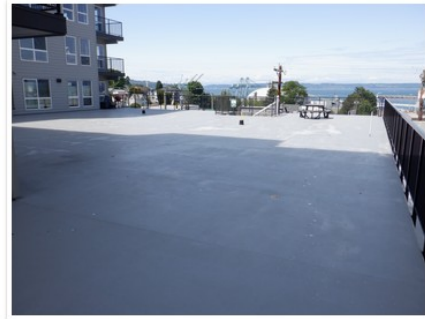
## Building Exterior - Courtyards: Recoat

This is believed to be the Master Builders Solutions product MasterSeal Pedestrian Traffic 2500 Primerless with a 10 year warranty. Installation date September 8, 2023. Warranty expires on September 7, 2033. See separate component for recoating.

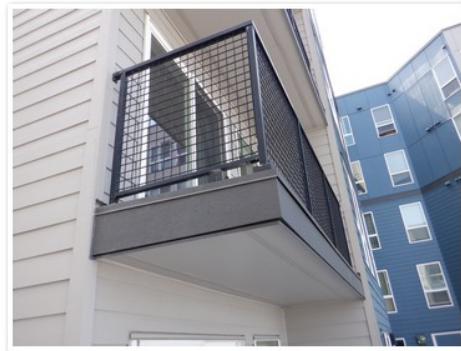
#### Building Exterior - Deck Railings, Metal: Repaint

Poor condition with rust observed during our limited scope visual inspection. Clean and repaint as needed for appearance.

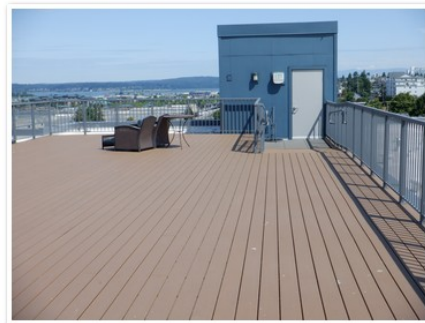
#### Building Exterior - Deck, Trex: Replace

The elevated decks in some of the community utilize a spaced composite board, possibly Trex, for the deck surface. Currently the surface of the decks are in generally good condition. Some adjacent wood trim boards have failed and are in need of replacement.

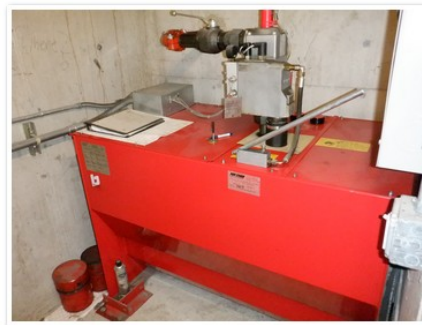
## Mechanical & Equipment - Elevator: Modernization

Reportedly functional with no major concerns. This component includes funding for a new controller, pump unit, electrical, etc. While we don't anticipate the need to replace the jack at this time, we suggest that it be inspected.

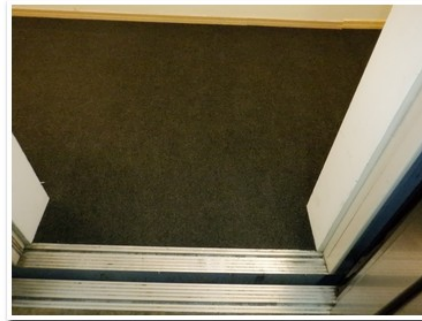
## **Building Interior - Flooring: Carpet, Replace**

Exact age unknown, however, generally good condition with no significant staining or deterioration observed.

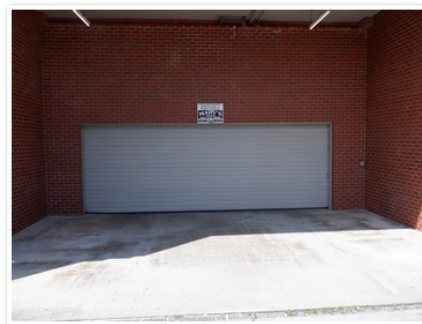
## **Mechanical & Equipment - Garage Door Operators: Replace, Remainder**

Generally fair condition with no significant dents and damage. These units can last an extended period of time if not damaged or abused. We recommend regular maintenance and lubrication as needed. Reserve funding recommended for replacement at the typical life expectancy of 20 years.

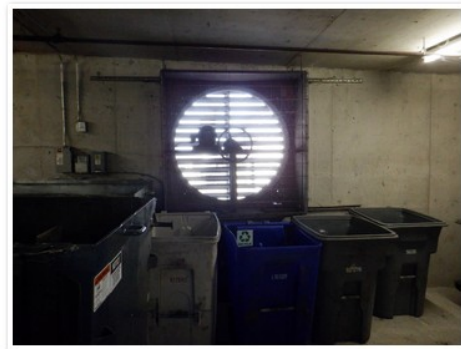
## Mechanical & Equipment - Garage Exhaust System: Repair

There is no expectation of complete replacement, however the sensors and fans will need to be replaced. We have included a small allowance for these.

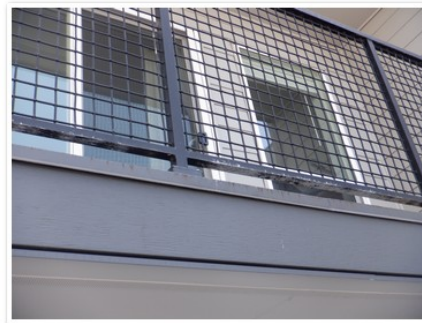
## Building Exterior - Guardrail: Metal, Repaint

Fair condition of the black steel guardrail. In need of repainting.

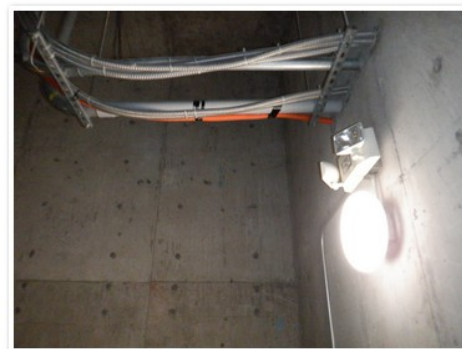
#### **Building Interior - Lights Interior: Stairwells, Replace**

Functional condition with no unusual deterioration or instability observed. No history of concern. Repair as needed from the operating budget. Best to plan for total replacement for appearance and functionality.

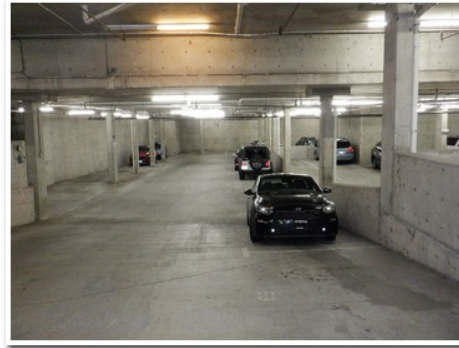
#### **Building Interior - Lights, Garage, Interior: Replace**

Fair condition with no unusual deterioration or instability observed. No history of concern. Repair as needed from the operating budget. Best to plan for total replacement for appearance and functionality.

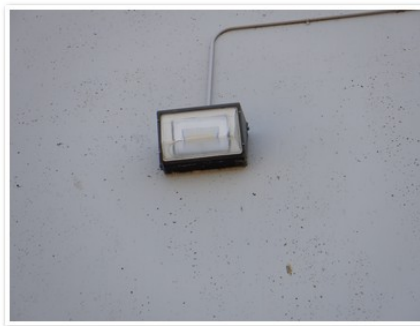
## Mechanical & Equipment - Lights: Exterior, Replace

Excellent condition with no unusual deterioration or instability observed. No history of concern. Repair as needed from the operating budget. Best to plan for total replacement for appearance and functionality.

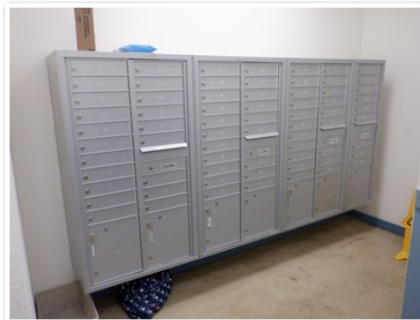
## Building Exterior - Mailbox Cluster: Replace

Fair condition of mailboxes with no unusual damage observed. Clean as needed to maintain appearance. Oil hinges to maintain ease of operation. Planned replacement in 2023.

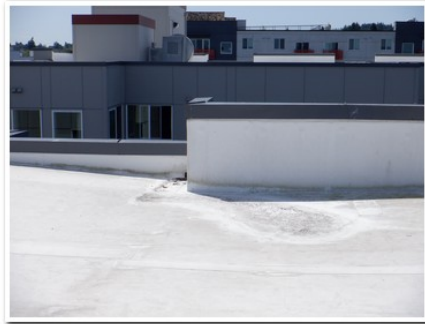
## Building Exterior - Roof: Low Slope, Replace, Building B

Excellent condition with no known concerns or issues reported or observed during our limited ground level inspection. Regular inspection by a qualified roofing professional is recommended to identify areas of concern or failure. Composition shingles should last their full design life with regular yearly moss removal, visual inspections and proper maintenance.

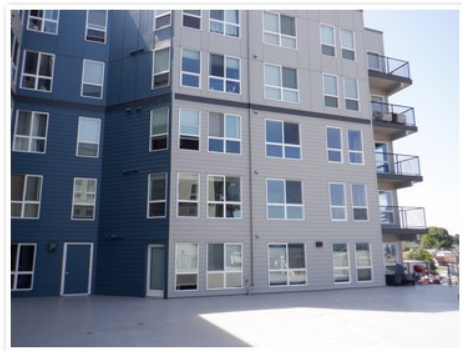
Excellent condition at this time with no peeling or fading of exterior surfaces. Regular paint cycles are important to maintaining and protecting the HardiPlank siding. Inspect regularly touch up paint and caulking as needed from the operating budget. To optimize the painting costs, we recommend that a professional painting and/or coating inspector be retained to inspect the existing paint film thickness and adhesion. A painting inspector can also prepare a written specification which would ensure that selected painting contractors are all quoting on the same products and methods of painting. The painting inspector can also perform wet film tests while the painting is being done to ensure that the correct amount of paint is being applied. The painting costs can be further optimized by repainting those wall elevations that receive the most weathering from sun and rain are repainted frequently enough. Similarly, those elevations, such as north facing walls, that do not require repainting as frequently the repainting cycle can be extended.

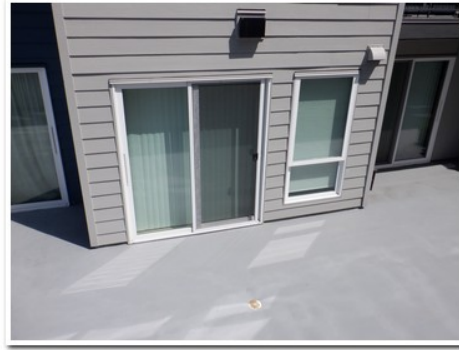
## Building Exterior - Sliding Glass Doors: Replace

Location: Each Unit  
 Quantity: 35 Each  
 UL: 50  
 RUL: 45  
 Current Cost: \$105,000  
 Condition: Excellent  
 Funding Basis: Funded based on the typical life expectancy

Excellent condition with no known water intrusion or concerns. We strongly recommend regular inspections and repair to ensure the integrity of the building envelope. Reserve funding recommended for eventual replacement at the typical life expectancy of 30 to 40 years. Should patterns of repair arise, additional funding may be included in future reserve studies, however, at this time there is no need.
