# **Reserve Study Level II**

**Prepared for Nautica Soundview**

**2026 Fiscal Year**

Prepared by CEDCORE, LLC

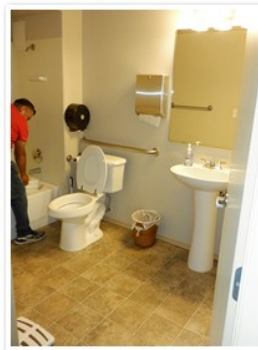
#### Building Interior - Bathroom: Refurbish

Location: Fitness Center  
 Quantity: 1 Allowance  
 UL: 20  
 RUL: 0  
 Current Cost: \$5,700  
 Condition: Fair  
 Funding Basis: Funded based on the typical life expectancy

We have included a modest allowance to update the bathrooms including flooring, painting, cabinets and fixtures.

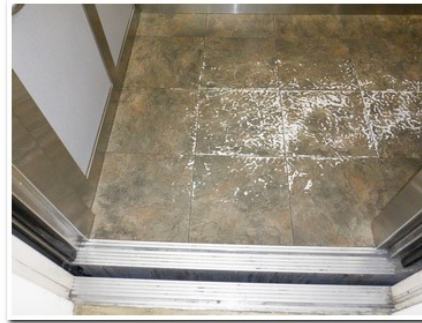
Condition: Good

Good condition with no concerns at this time. This component suggest planning for cycles of interior surfaces replacement for aesthetics. We suggest a funding allowance every 15 to 30 years.

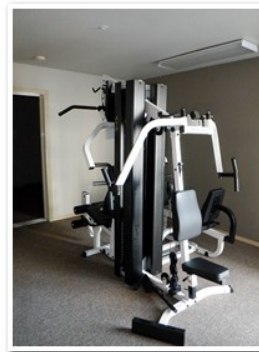
Condition: Assorted Condition

Reportedly all equipment is functional with no concerns at this time. We recommend regular inspections and repair as needed. The life expectancy varies greatly based on frequency of use, quality etc. We have included a funding allowance for partial repair/replacement every 12 years.

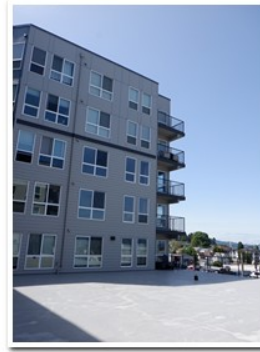
Condition: Excellent

No reported problems observed or reported during our site inspection. No widespread damage or indications of early replacement indicated. In general keep clean and free of debris to ensure proper functionality. Reserve funding recommended for replacement timed to coincide with roof replacement projects for cost efficiency.

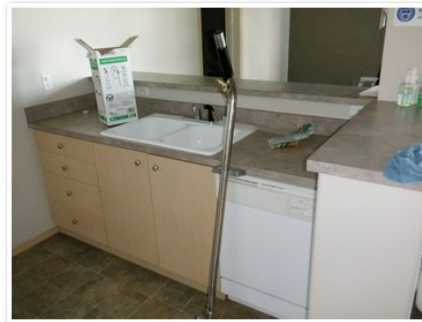
Condition: Fair

This allowance may be used for replacement and refurbishment of the kitchen. Currently in good condition with no significant deterioration noted. Adjust funding based on the desires of the Board.

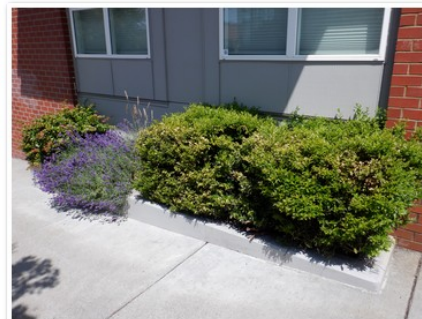
#### Site/Grounds - Landscaping: Refurbish

Condition: Assorted Condition

This component may be used to fund large landscape projects not budgeted within the Operating Budget. This expense may vary greatly depending on the desires of the Board. We suggest starting with an allowance every couple of years to complete cycles of refurbishment such as replanting's, bark mulch etc.

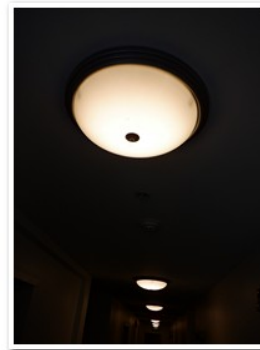
Condition: Excellent

Good condition with no unusual deterioration or instability observed. No history of concern. Repair as needed from the operating budget. Best to plan for total replacement for appearance and functionality.

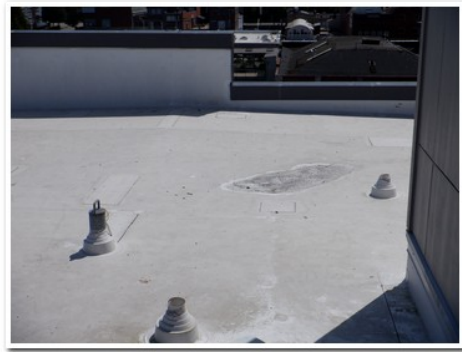
Condition: Excellent

Excellent condition with no known concerns or issues reported or observed during our limited ground level inspection. Regular inspection by a qualified roofing professional is recommended to identify areas of concern or failure. Composition shingles should last their full design life with regular yearly moss removal, visual inspections and proper maintenance.

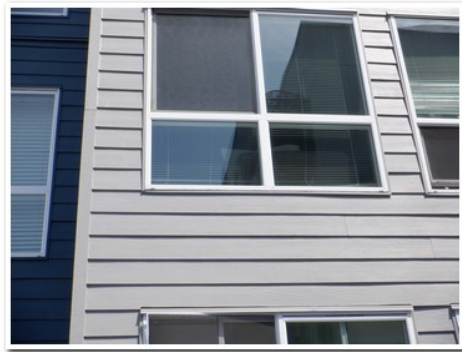
Funding for siding and trim that has deteriorated and should be replaced prior to each repainting cycle after the first one.

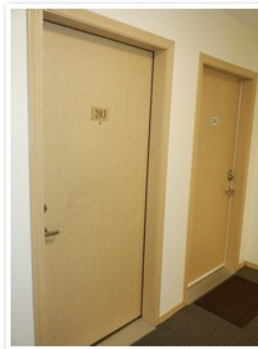
## Building Interior - Suite Entry Doors Hardware: Replace

Location: Throughout  
 Quantity: 128 Each  
 UL: 50  
 RUL: 26  
 Current Cost: \$38,400  
 Condition: Good  
 Funding Basis: Funded based on the typical life expectancy

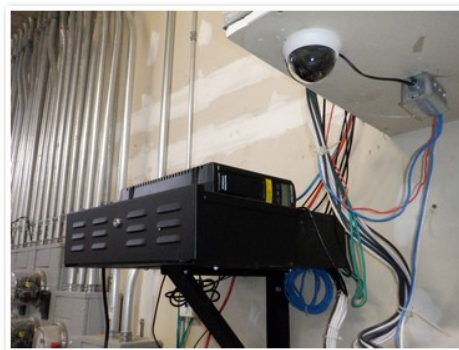
## Mechanical & Equipment - Surveillance System: Replace

Location: Various  
 Quantity: 1 Allowance  
 UL: 18  
 RUL: 0  
 Current Cost: \$8,900  
 Condition: Unknown  
 Funding Basis: Funded based on the typical life expectancy

This component may be used to fund partial replacement as needed. These systems typically become technologically obsolete before they become nonfunctional.

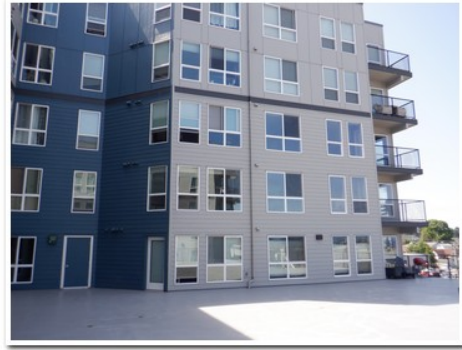
Condition: Good

Excellent condition with no known water intrusion or concerns. We strongly recommend regular inspections and repair to ensure the integrity of the building envelope. Reserve funding recommended for eventual replacement at the typical life expectancy of 30 to 40 years. Should patterns of repair arise, additional funding may be included in future reserve studies, however, at this time there is no need.
